Design, Verification, and Forensic Correlation of Composite Yacht Structures

**Paul H. Miller, D. Eng. P.E.
United States Naval Academy
Annapolis, Maryland, USA**

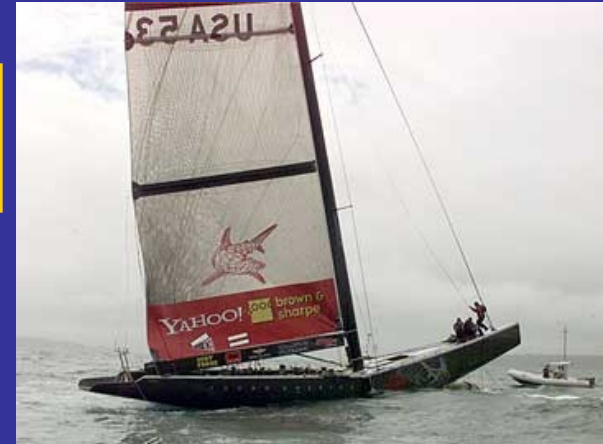
1. Risk Analysis

2. Uncertainty Identification

3. Targeted Performance and Structural Evaluation (FOS=1 to 8+)

Risk Analysis

Mat'l Tests

Test Design/
Experimental Verification/
Tool Calibration

Final Design

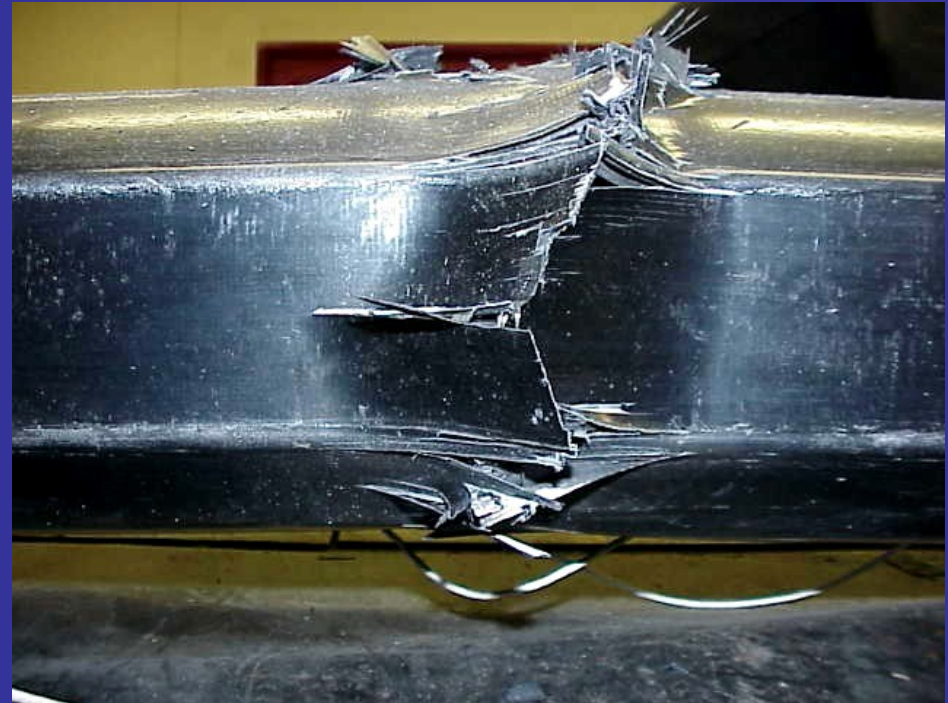
Rig Test

Compression and Impact

- Buckling limited
- “Risky” and “Likely”
- Weight critical
- Resin content evaluated
- Sidewall thickness decreased from 6 to 3 mm
- 72% to 89% of FEA

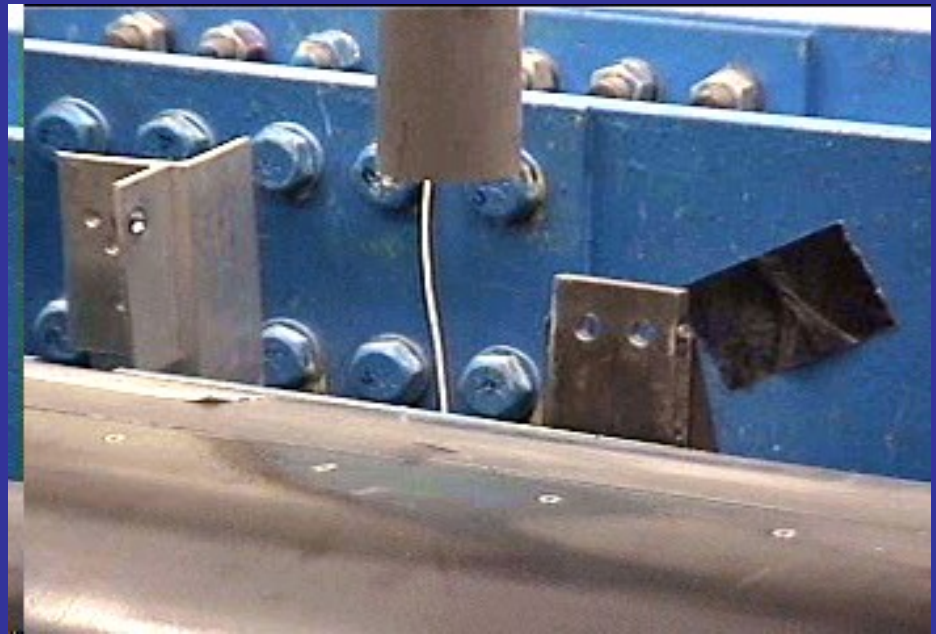
Rig Test

Compression and Impact

- “Highest Consequence” Event Simulated, Load & Geometry
- Adopted “damage tolerant” design (resin, stacking sequence)
- Both passed, 1 punctured

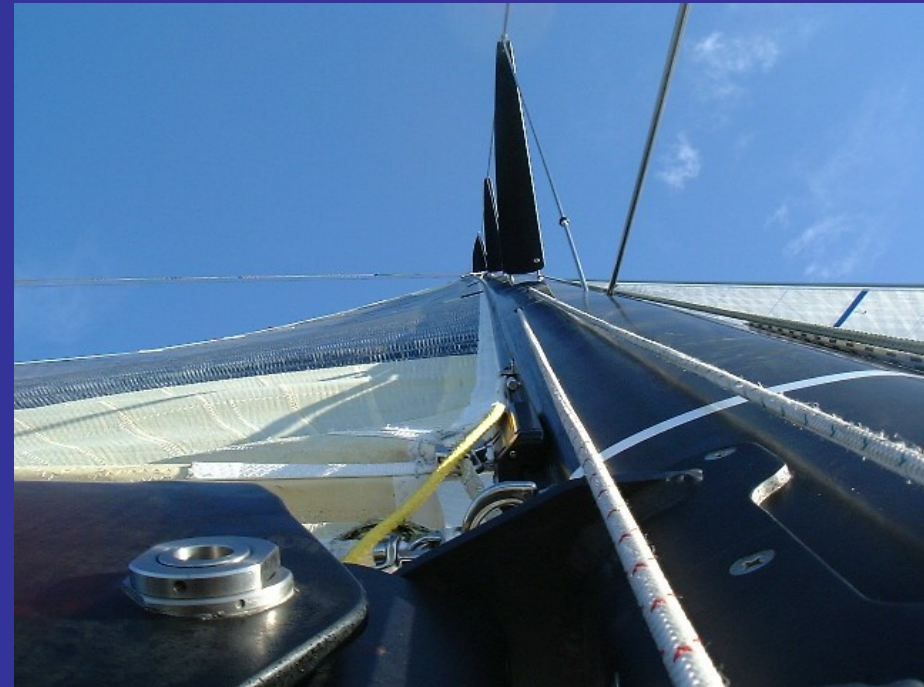
Mast #1

- Failure after 13 hours of use
- Winds of 14-17 kts at the time (23 the day before but less tension)
- 6 possible failure scenarios, all evaluated by FEA, one had 1.0 FOS.

Three minutes before failure

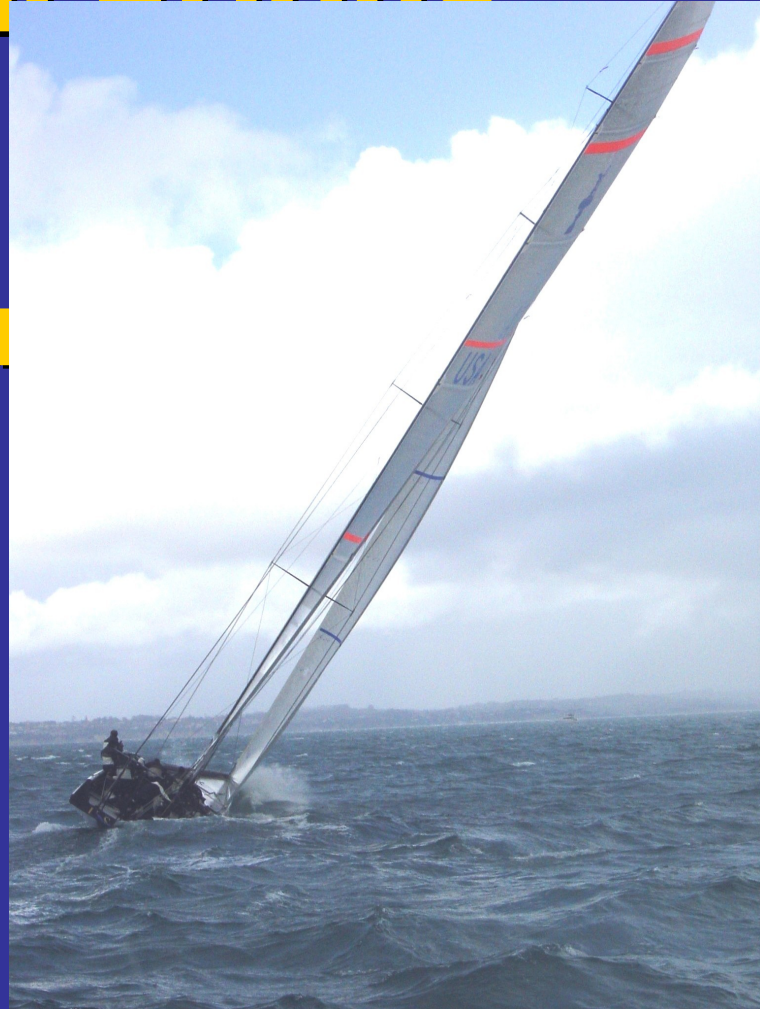
Rig (Reactive) Modifications

- Mast 2: extra reinforcement
- Mast 3: improved QA
- Mast 4: same as Mast 1
- Mast 5: reduced structure

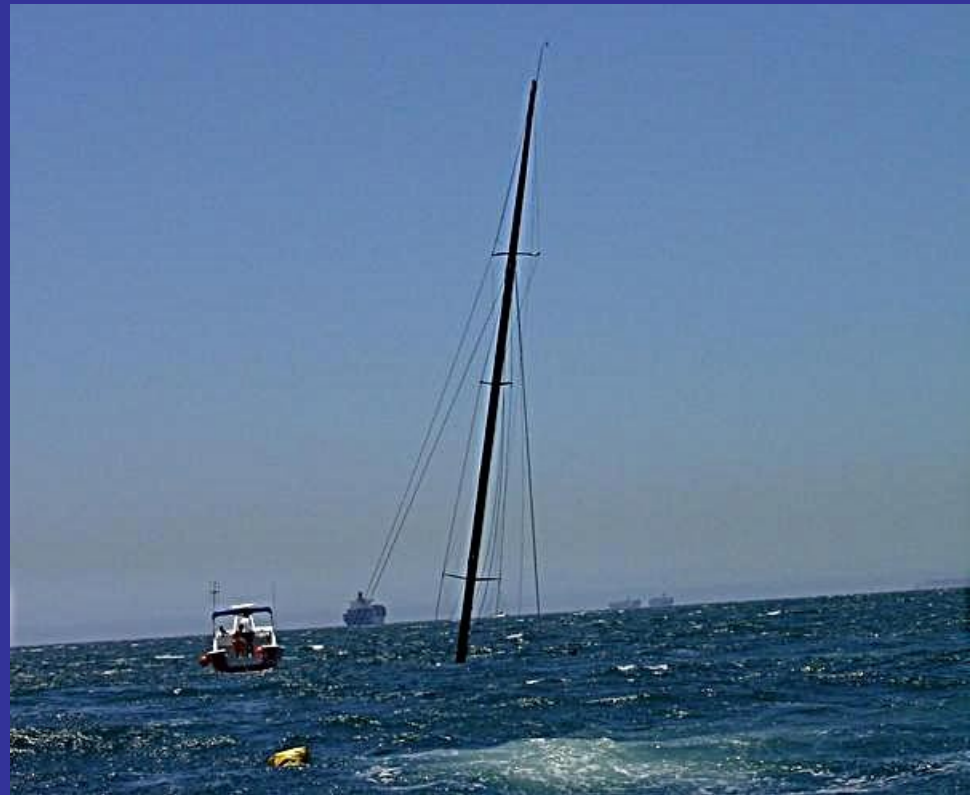
IACC USA-77 Hull

- Sank after “rudder failure”, traced to poor QA and bad communication
- FEA identified possible damage spots
- All but one found
- Assisted in repairs
- Vessel regained competitive status

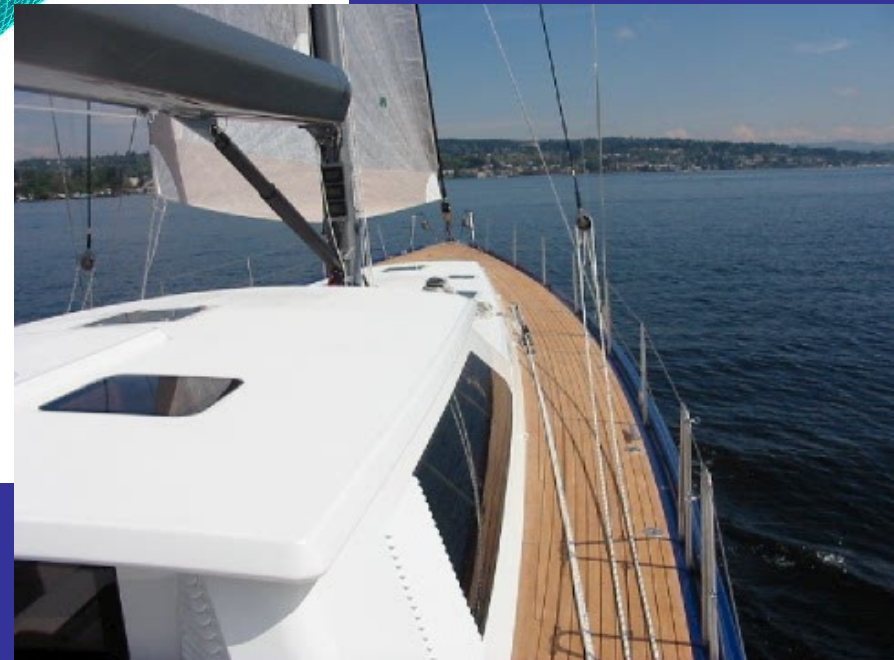
Slide 14

S/V Cascadia Hull

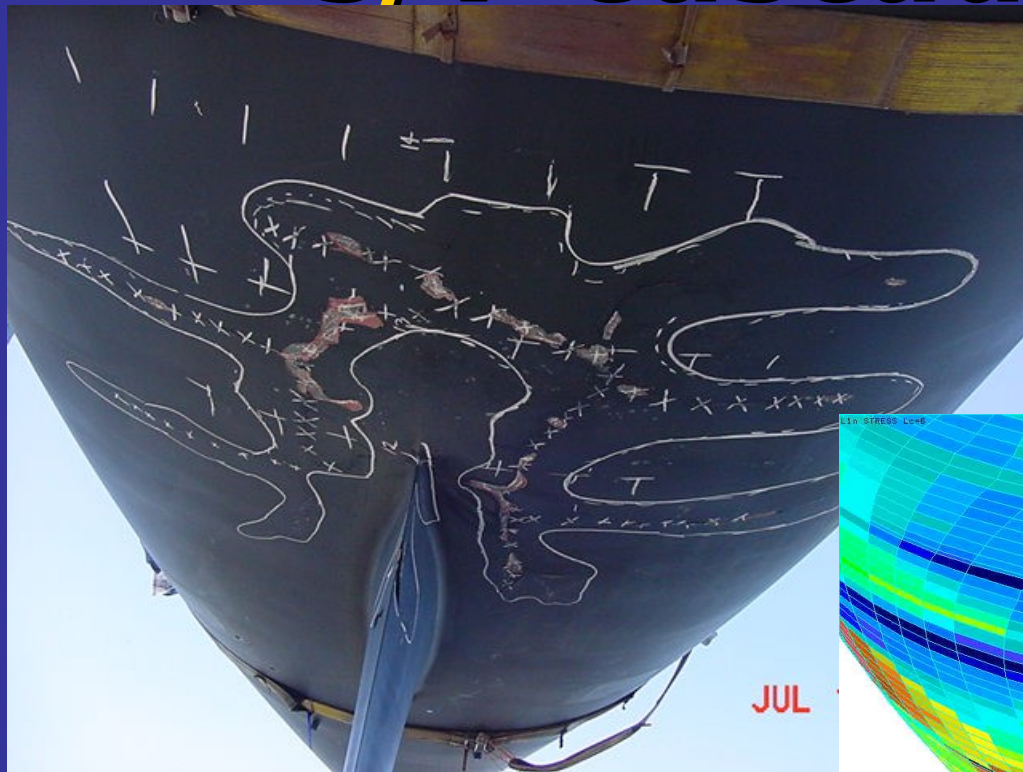
Outer Ply Factor of Safety

S/V Cascadia Hull
